CAUCASUS HERITAGE WATCH

MONITORING REPORT
JUNE 2024

Monitoring Report #7
June 2024

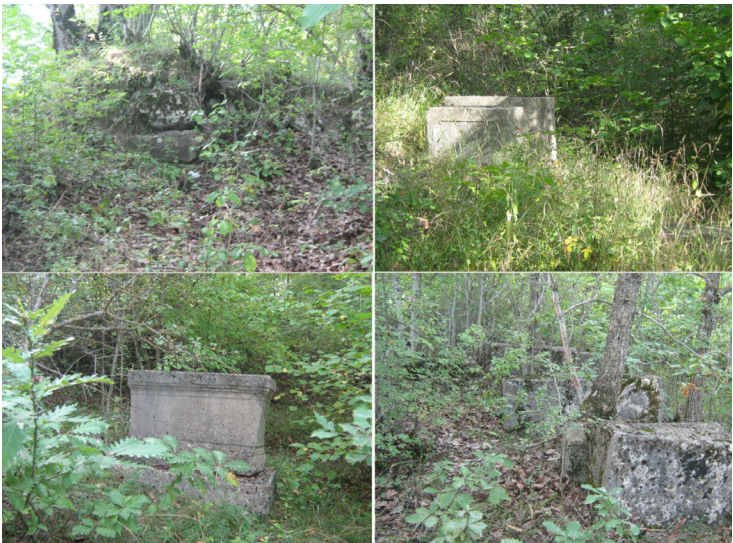
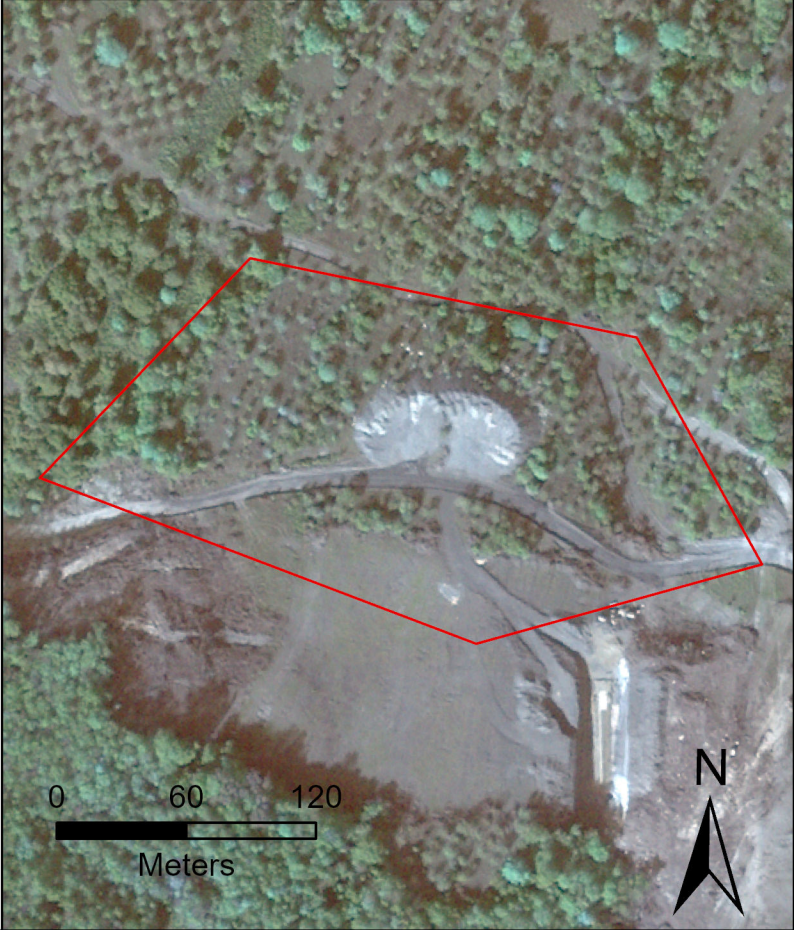
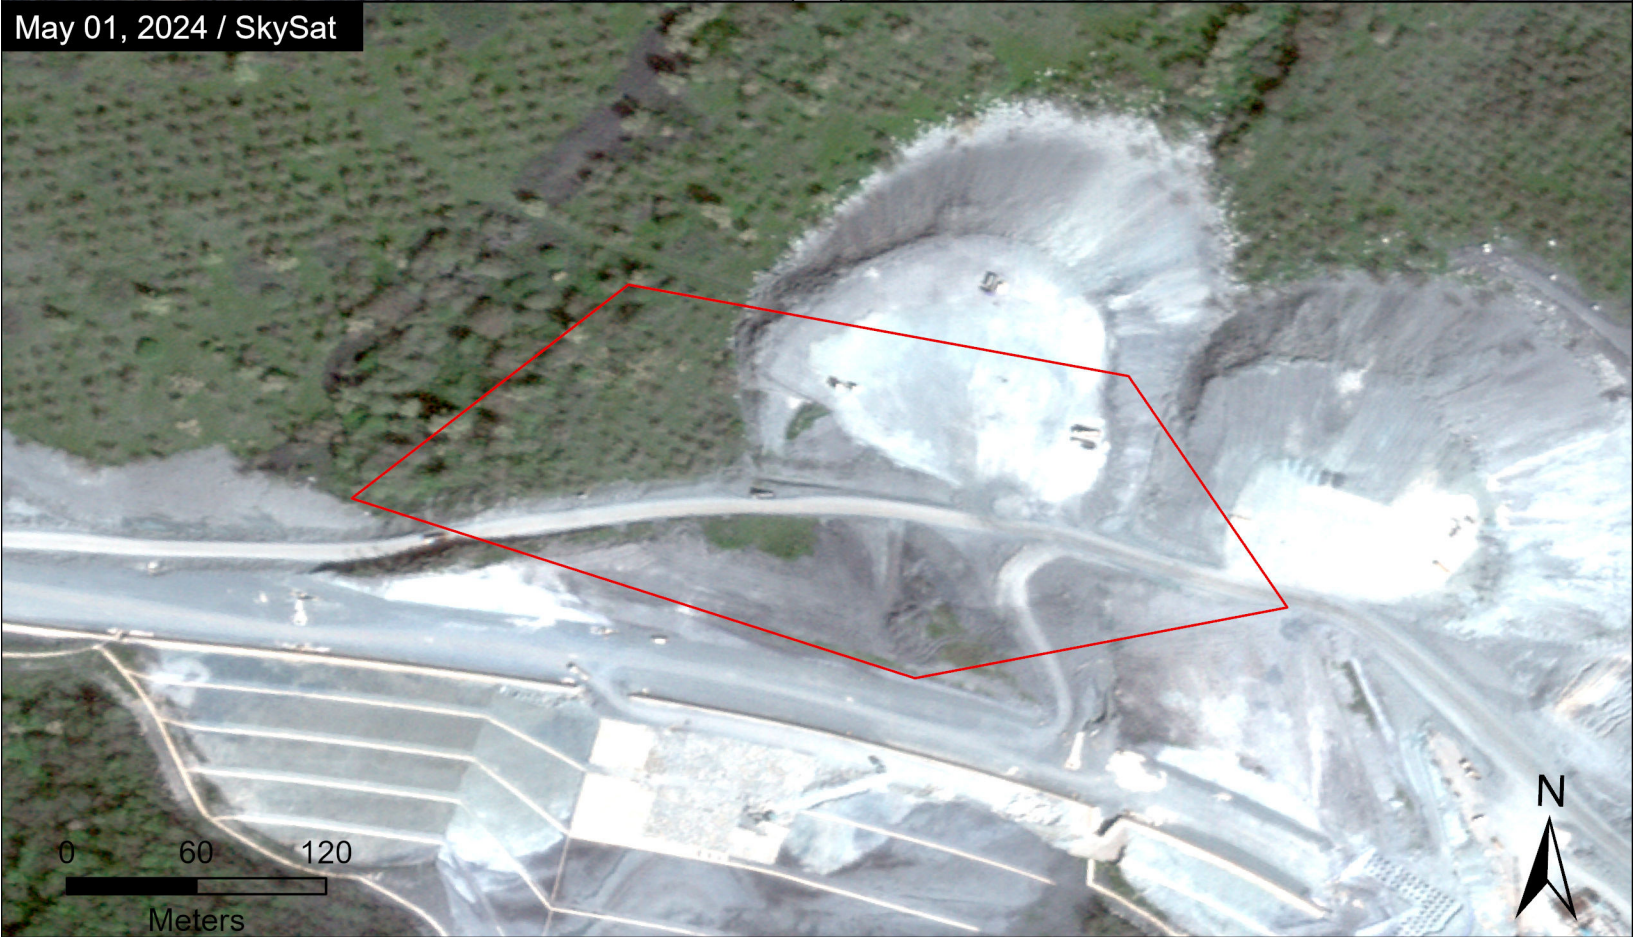
AN.038-0 Ghuze T'agh Cemetery near
Garabulag/Aknaghbyur

AN.038-0	Ghuze T'agh Cemetery
Location	near Garabulag/Aknaghbyur
Dates	19th - early 20th century
Baseline Image	2023-10-05 / SkySat
Monitoring Image	2024-06-02 / WorldView 2 ©2024 MAXAR
Current Status	Destroyed
Notes	<p>The cemetery is located southwest of the village. It has not been systematically studied, but according to inscriptions on the tombstones, the cemetery dates to the 19th and early 20th centuries. The number of tombstones is unknown. CHW was able to determine the precise limits of the cemetery using a plan included on the official certificate for the site, created by the Ministry of Education and Science of the unrecognized Republic of Nagorno-Karabakh and provided by our partner, Monument Watch. That certificate also shows that the remains of a shrine, or "maturr" existed in the cemetery.</p> <p>The cemetery was last seen fully intact in February 2021 (at right, top left). By October 2021 (at right, top right) earthmoving related to roadwork had already severely impacted the area of the cemetery. As of May 1, 2024, CHW assesses the cemetery as destroyed.</p>

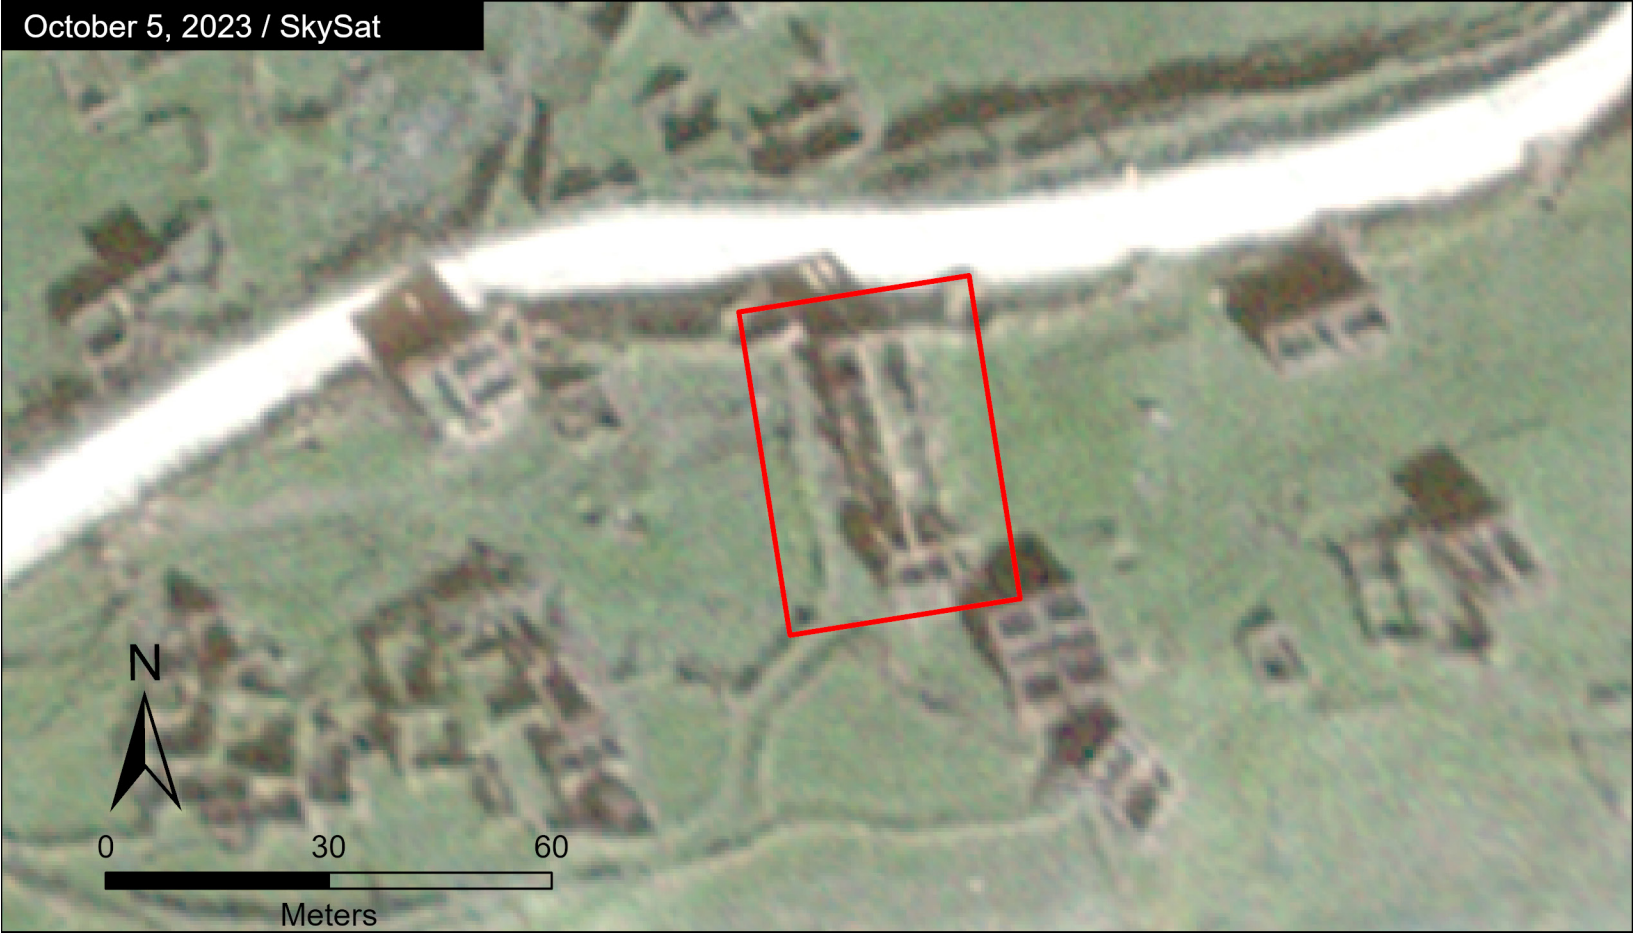
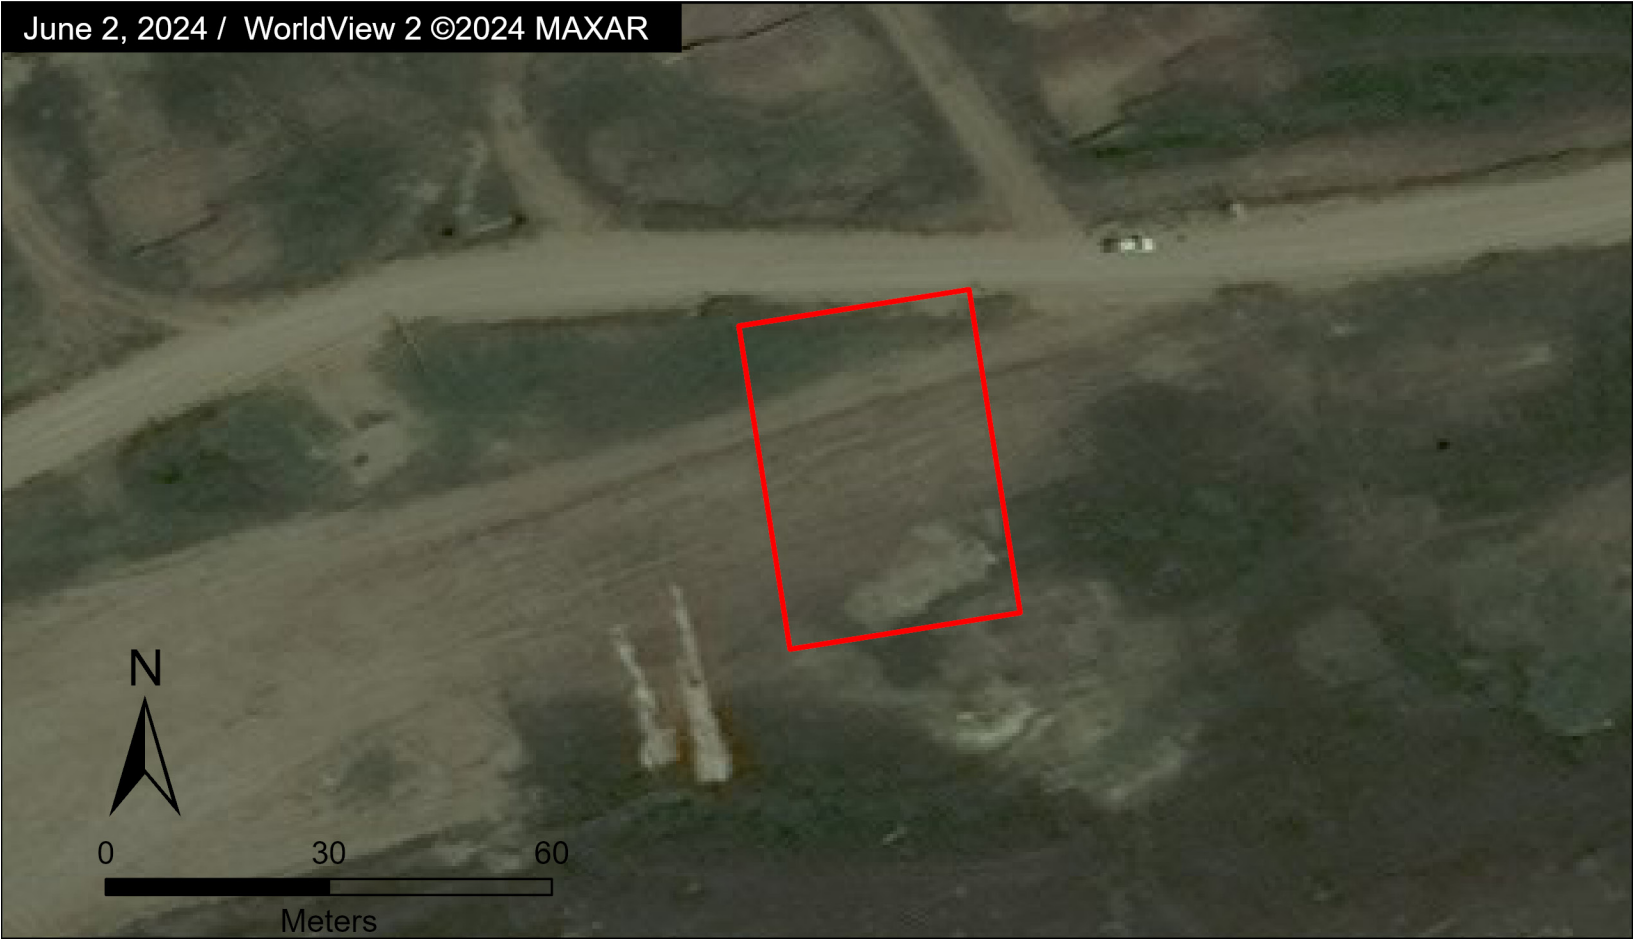
KR.022-0. Zar / Tsar School

Destroyed Heritage	
KR.022-0	Zar School
Location	Zar/Tsar
Dates	Structure: 1950s; Spolia: Medieval
Baseline Image	2023-10-05 / SkySat
Monitoring Image	2024-06-02 / WorldView 2 ©2024 MAXAR
Current Status	Destroyed
Notes	<p>The Zar school is a truly unique heritage site. It was built in the 1950s using "spolia" from medieval Armenian churches and cemeteries in the area -- including inscribed stones, khachkars, and ornamental relief elements. Soviet Azerbaijan destroyed the medieval monuments during the 1940s and 1950s. The school was active until Armenian forces drove Azerbaijani families out the village in the spring of 1993. The building was looted and fell into ruins until it was razed in the Spring of 2024. The structure thus constitutes a unique testament to repeating cycles of violence in Nagorno-Karabakh, from cultural erasure by the authorities of Soviet Azerbaijan to heritage mining by Armenian residents of the unrecognized Nagorno-Karabakh Republic, to its ultimate bulldozing by Azerbaijan following the Second Nagorno-Karabakh War.</p> <p>The skeleton of the building remained intact for several CHW missions following the 2020 war, even after work on the adjacent road led to a threat alert in June 2024 (at right, top). Between October 5, 2023 and June 2, 2024, the school was razed (at right, bottom), along with most of the other ruins of Zar/ Tsar.</p>

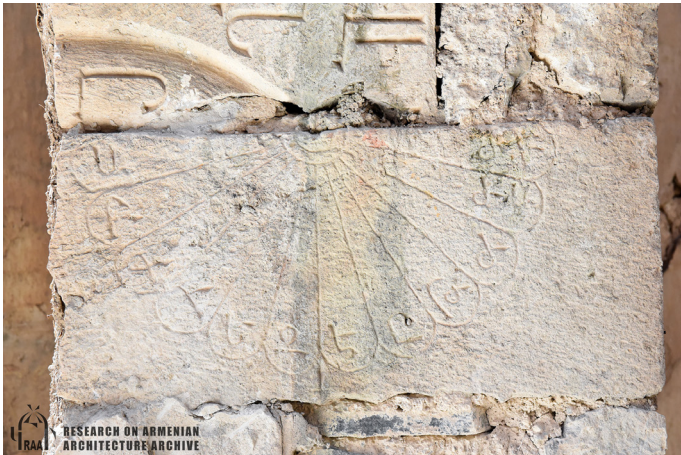
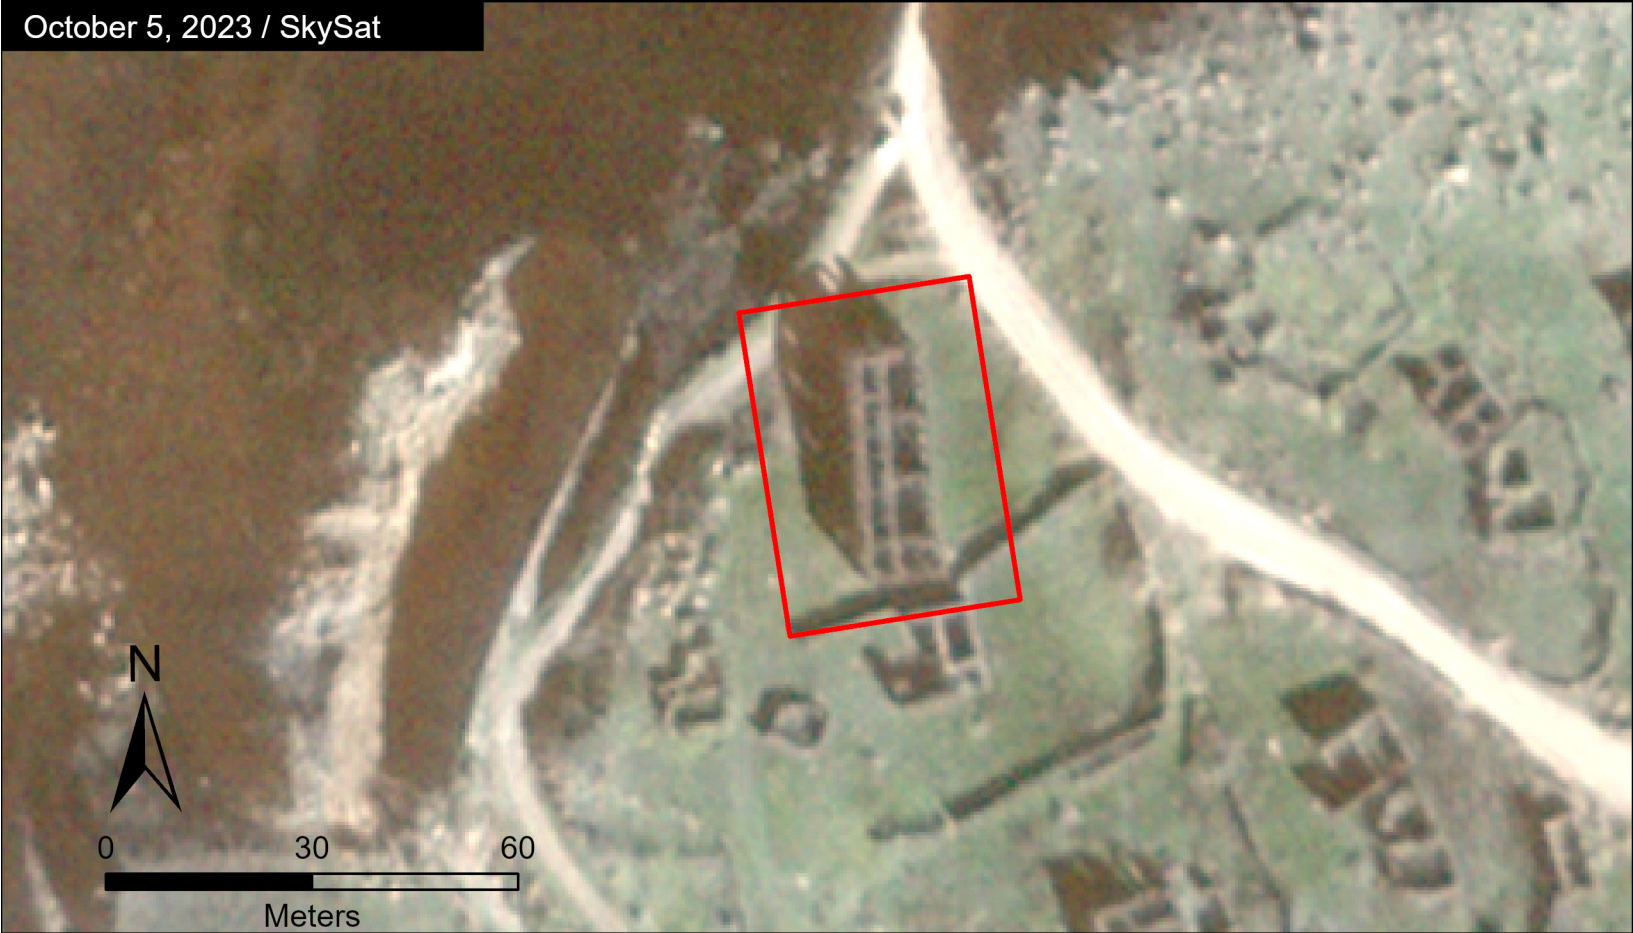
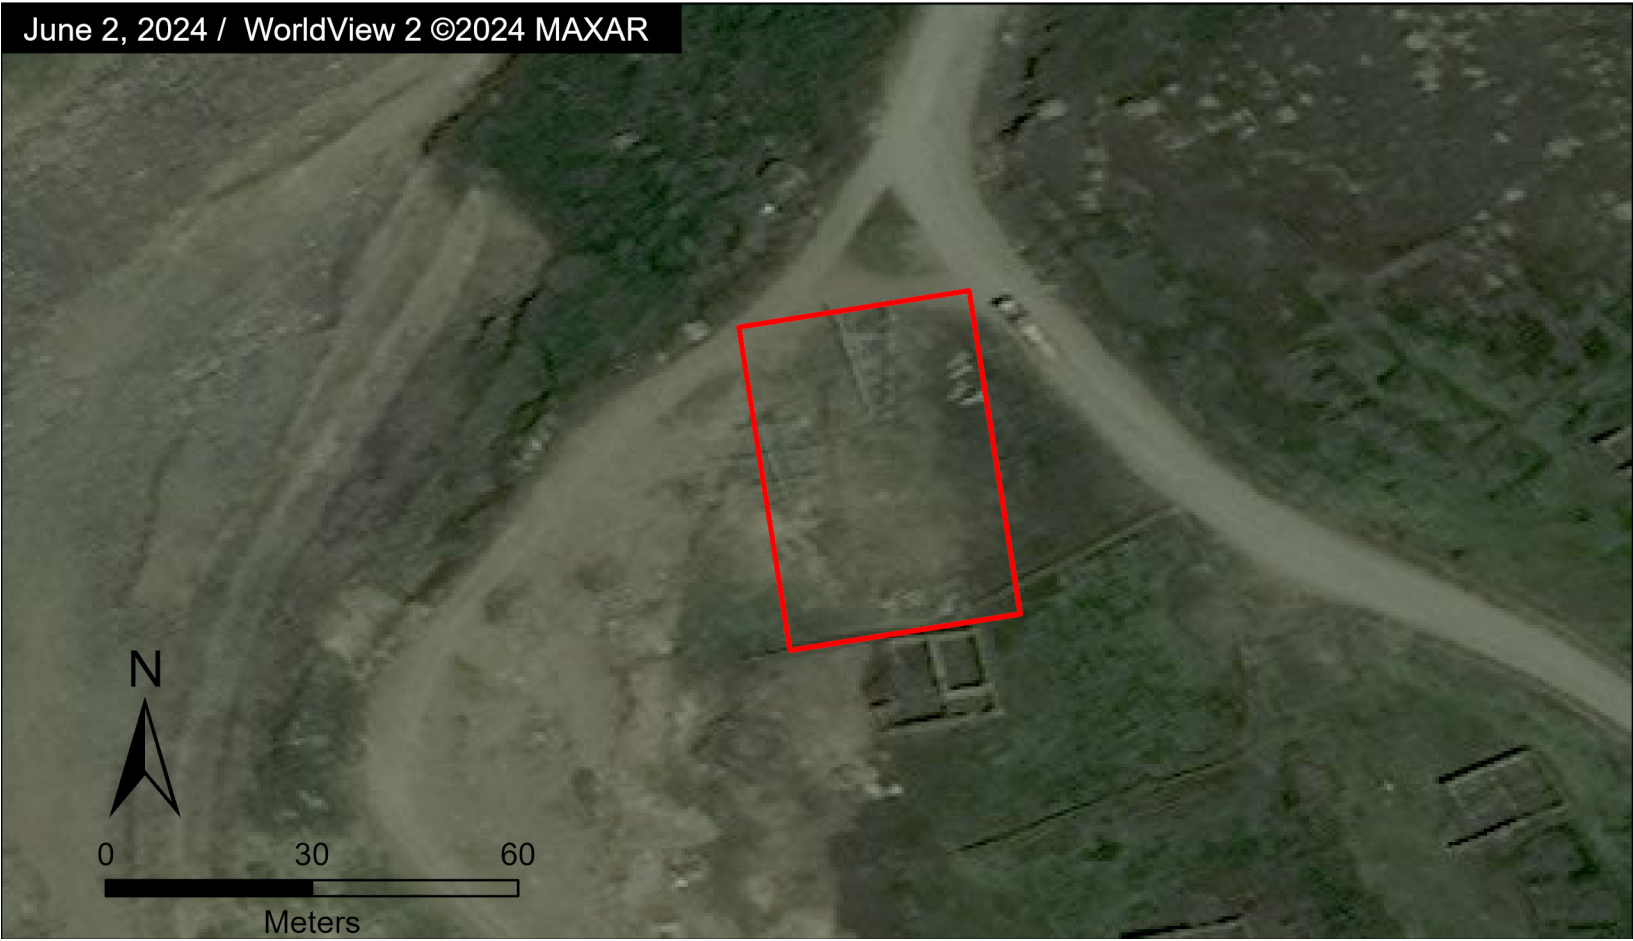
KR.063-0. Chirag / Chragh School

KR.063-0	Chirag school
Location	Chirag/Chragh
Dates	Structure: 1950s; Spolia: Medieval
Baseline Image	2023-10-05 / SkySat
Monitoring Image	2024-06-02 / WorldView 2 ©2024 MAXAR
Current Status	Destroyed
Notes	<p>Like the Zar school, the Chirag school was also built in the 1950s using "spolia" from medieval Armenian churches and cemeteries in the area. Soviet Azerbaijan destroyed the medieval monuments during the 1940s and 1950s. The school was active until Armenian forces drove Azerbaijani families out the village in the spring of 1993. The building was looted and fell into ruins until it was razed in the Spring of 2024. The structure thus constitutes a unique testament to repeating cycles of violence in Nagorno-Karabakh from cultural erasure by the authorities of Soviet Azerbaijan to heritage mining by Armenian residents of the unrecognized Nagorno-Karabakh Republic to its ultimate bulldozing by Azerbaijan following the Second Nagorno-Karabakh War.</p> <p>The skeleton of the building remained intact for several CHW missions following the 2020 war, even after work on the adjacent road led to a threat alert in June 2024 (at right, top). Between October 5, 2023 and June 2, 2024, the school was razed (at right, bottom).</p>

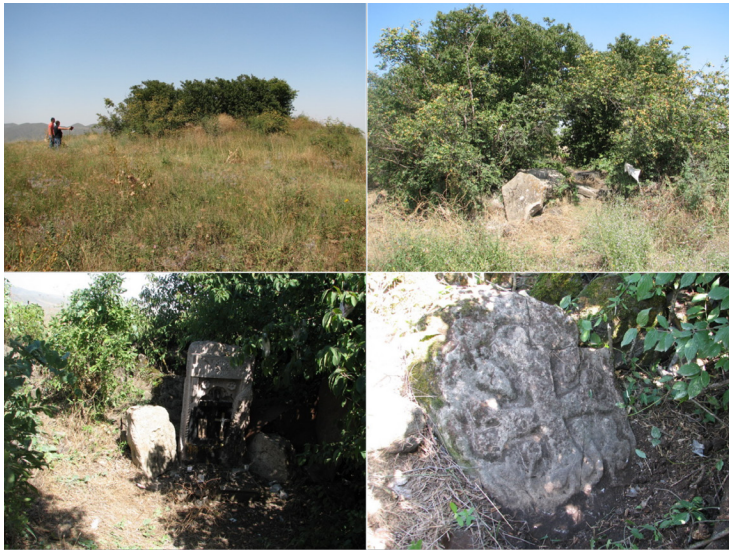
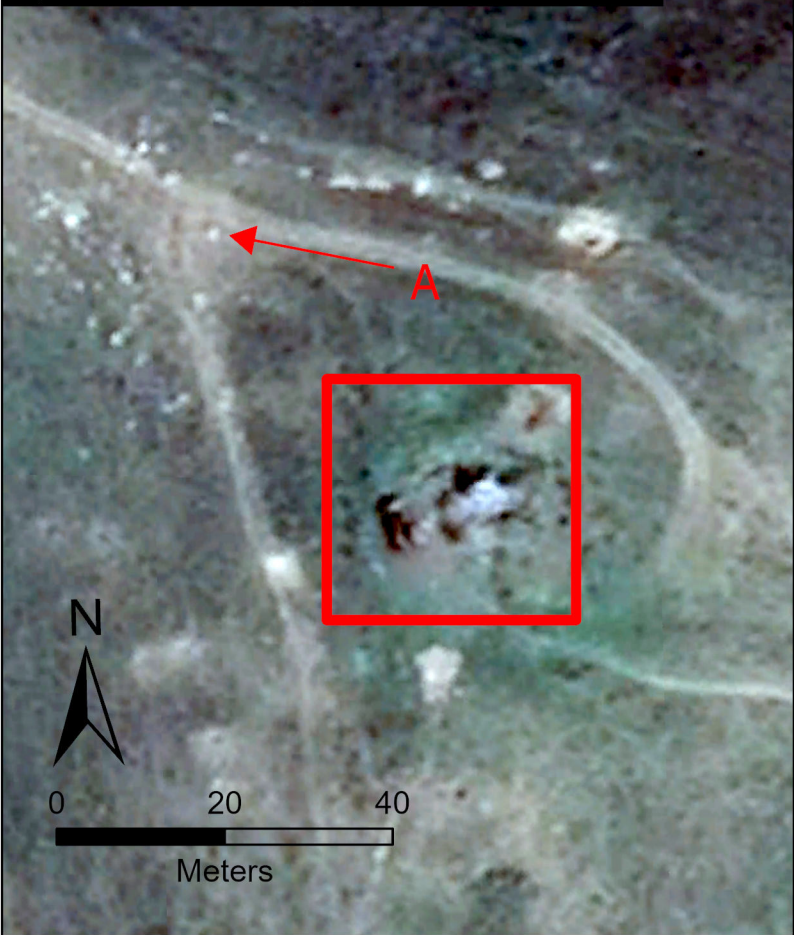
MI.079-0 Kohak Sacred Place, Chartar

MI.079-0	Kohak Sacred Place
Location	Chartar
Dates	9th-13th centuries
Baseline Image	2020-09-18 / Google Earth-Maxar
Monitoring Image	2021-04-14 / Google Earth-CNES/Airbus & 2024-04-28 / SkySat
Current Status	Destroyed
Notes	<p>Described on the monument list of the former NKR as a "sacred place", this site, located on the top of a hill, consisted of the ruins of a church, amidst which were three khachkars and one khachkar pedestal. One of the khachkars dated to the 9th century, while the other three dated to the 13th century. The church -- a single nave basilica with a semi-circular apse -- was already in such a ruinous state when officials of the former NKR documented it that it was difficult to determine the full site plan.</p> <p>The site appears to have been initially impacted by shelling during the Fall 2020 war. An April 14, 2021 image (at right, top right) shows the central area has collapsed and stone ejecta litters the area to the northwest (A) suggesting a strike from the southeast. Most of the site was destroyed by October 2023 (at right, bottom left) and by April 28, 2024 (at right, bottom right), earthmoving and construction appear to have destroyed the last remnants of the sacred place.</p>

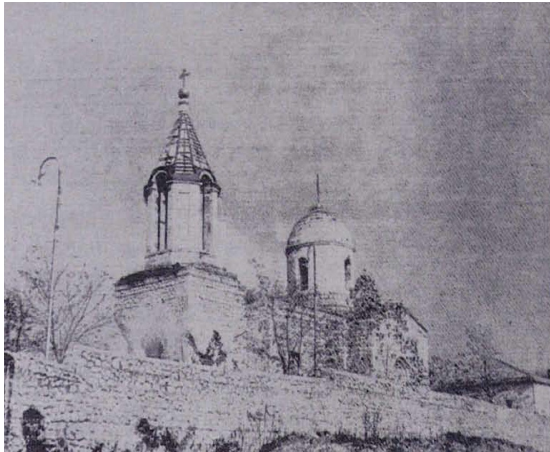
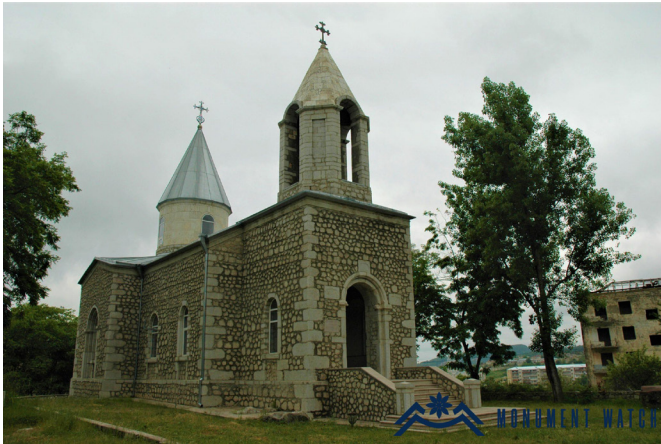
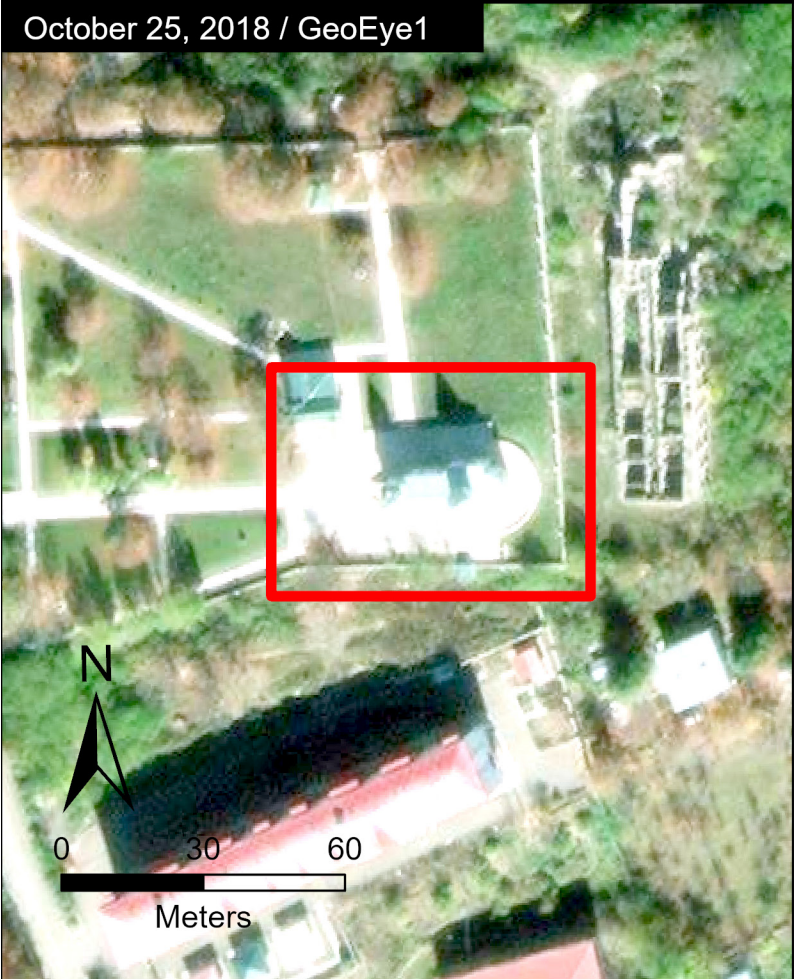
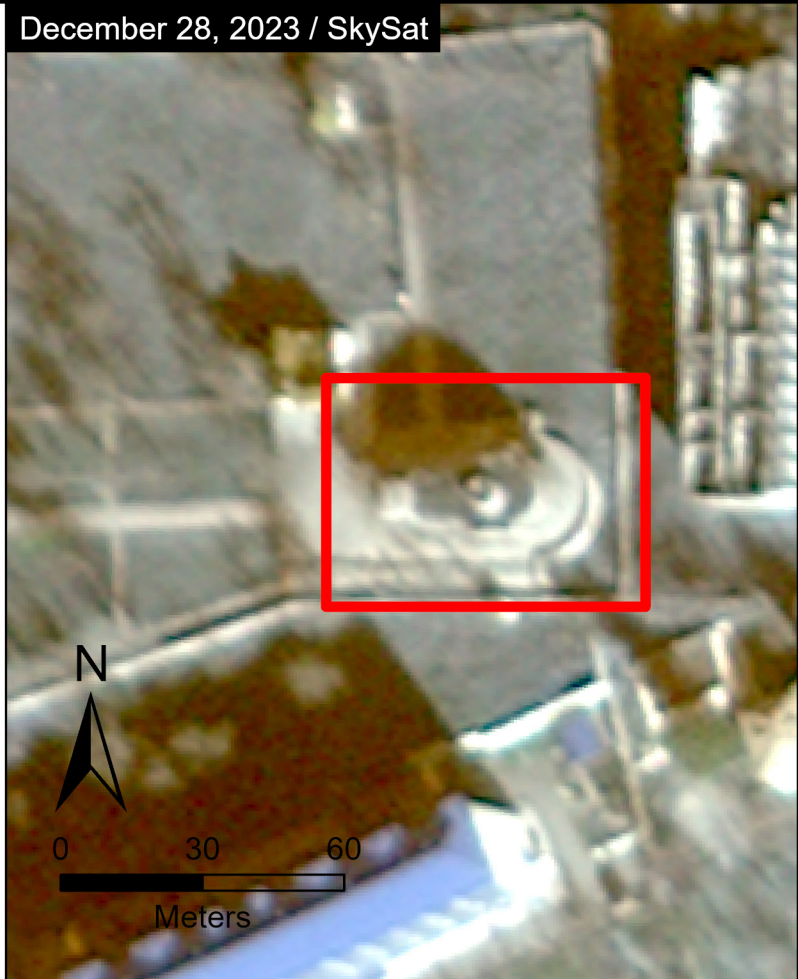
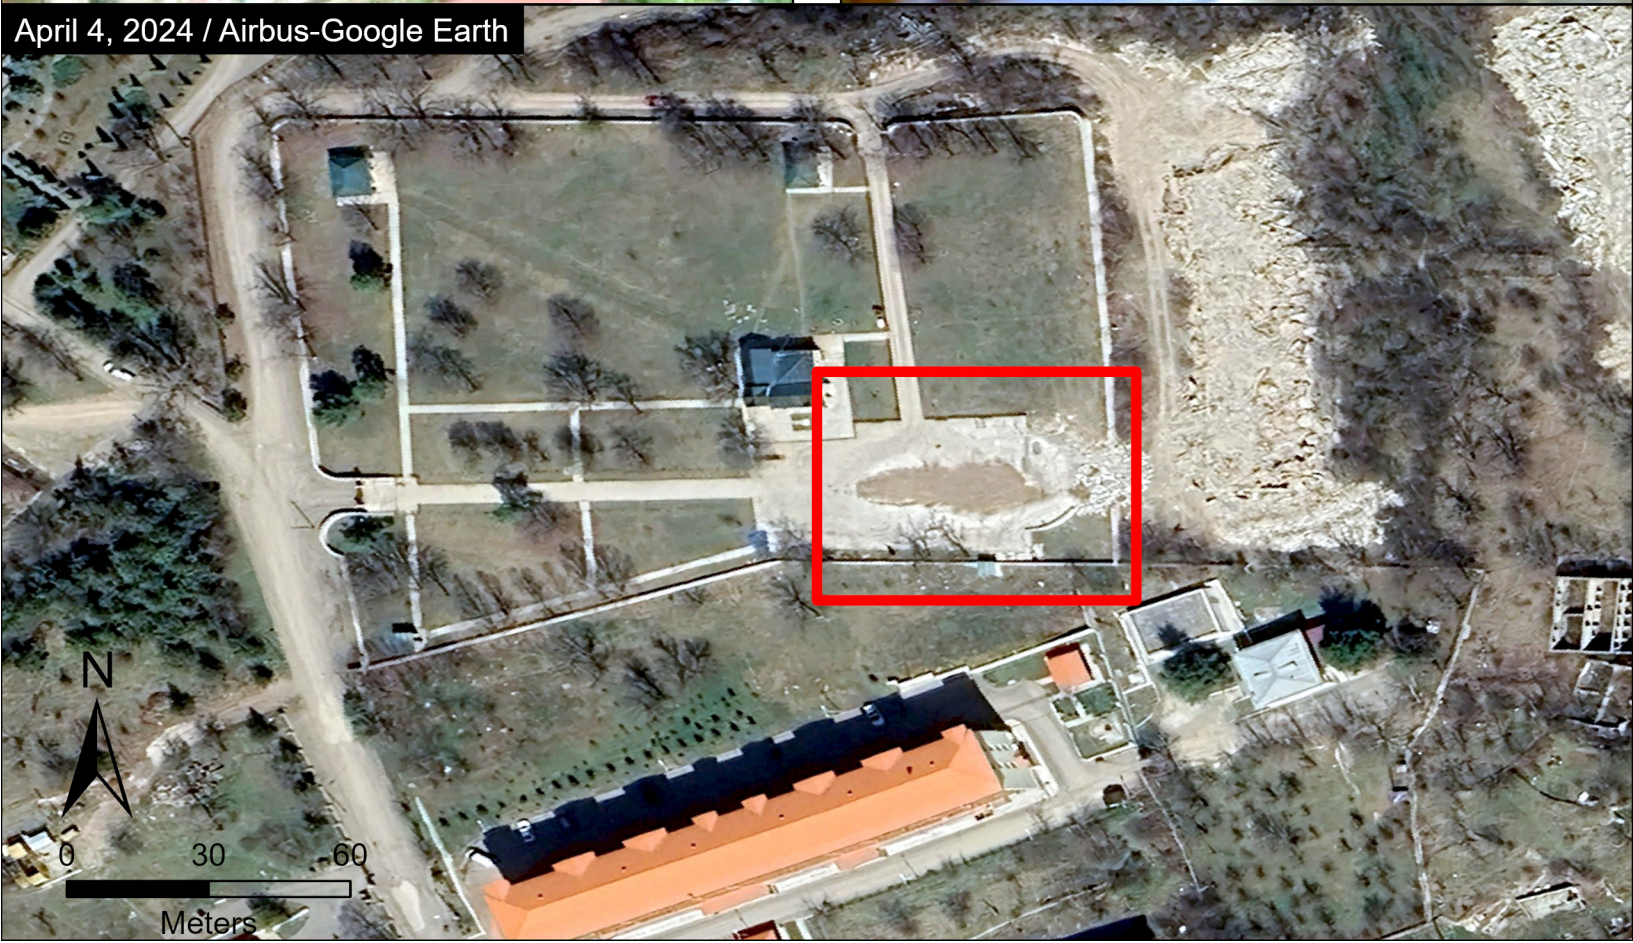
SH.053-0 St. Hovhannes Mkrtych Church (Kanach Zham),
Shushi/Shusha

SH.053-0	St. Hovhannes Mkrtych Church (Kanach Zham)
Location	Shusha/Shushi
Dates	Constructed 1858
Baseline Image	2018-10-25 / GeoEye1
Monitoring Image	2023-12-28 / SkySat & 2024-04-04 / Airbus-Google Earth
Current Status	Destroyed
Notes	<p>St. Hovhannes Mkrtych Church (known as Kanach Zham) was significantly impacted during the Second Nagorno-Karabakh War in 2020. As we reported in CHW Monitoring Reports #1 and #2, the church originally possessed two cupolas, both clearly visible in baseline imagery from October 25, 2020 casting tall peaked shadows. An April 2021 image published in CHW Monitoring Report #2 showed the wartime damage to the structure which included the removal of the western cupola and a hole in the rook where the eastern cupola had been. Subsequent imagery, including the December 2023 image at right, indicated that the debris left by the 2020 fighting had been removed and some effort had been made to stabilize the eastern cupola and perhaps repair the hole in the roof. However, imagery released on Google Earth from April 4, 2024 clearly shows the complete demolition of the church.</p>

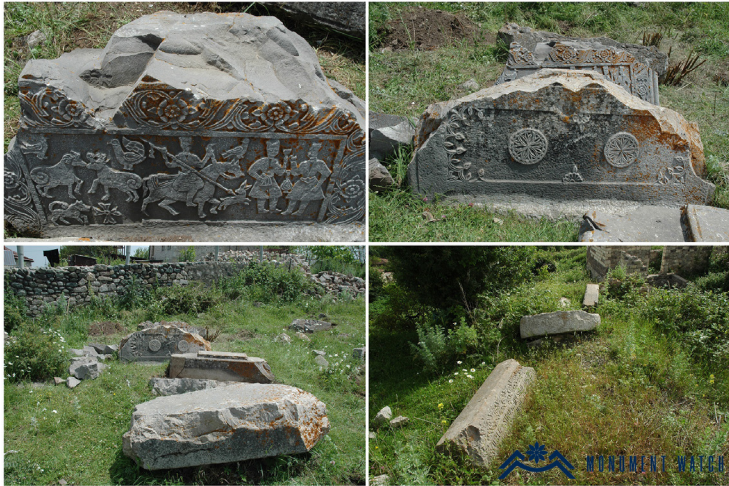
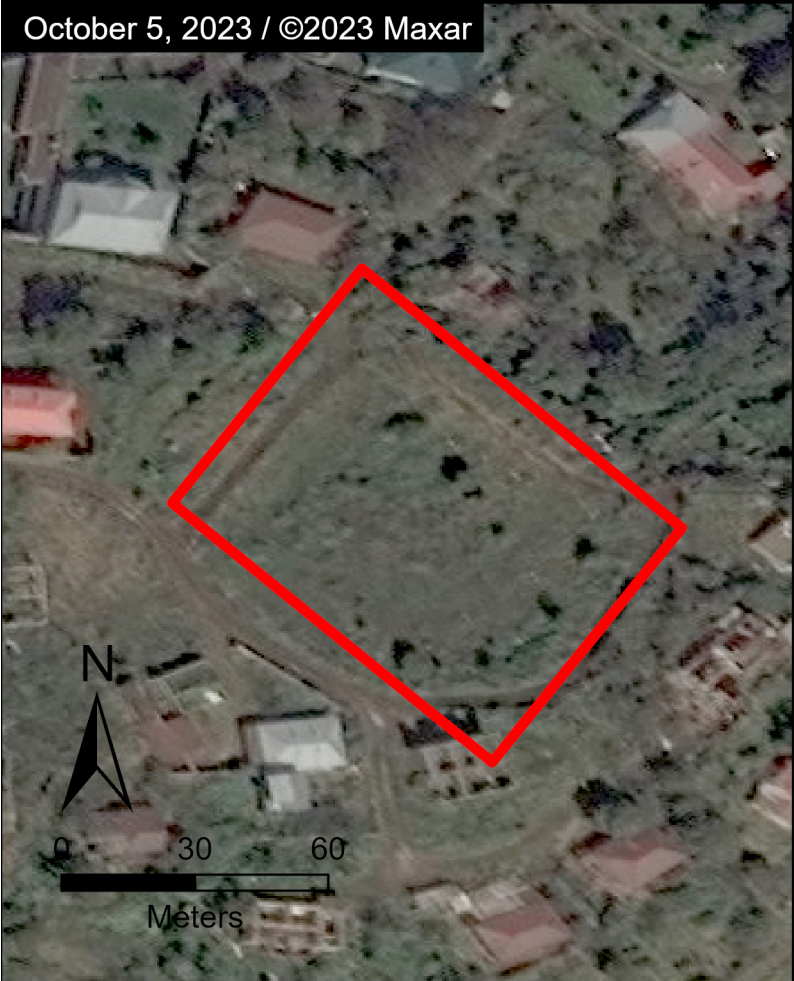
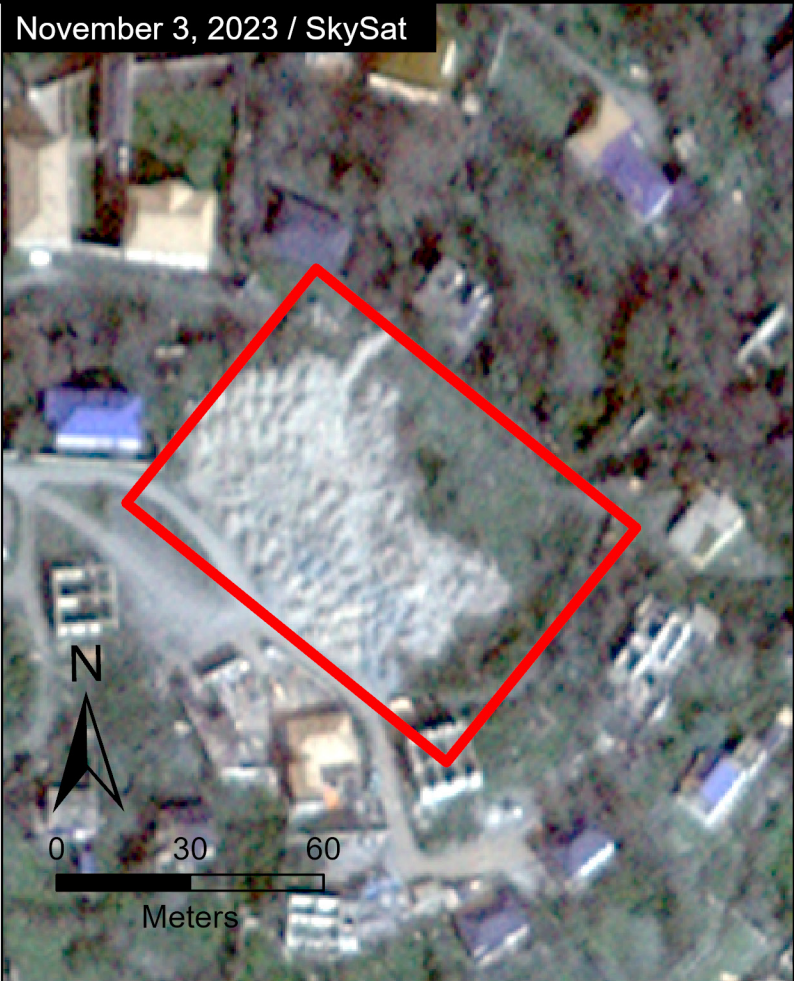
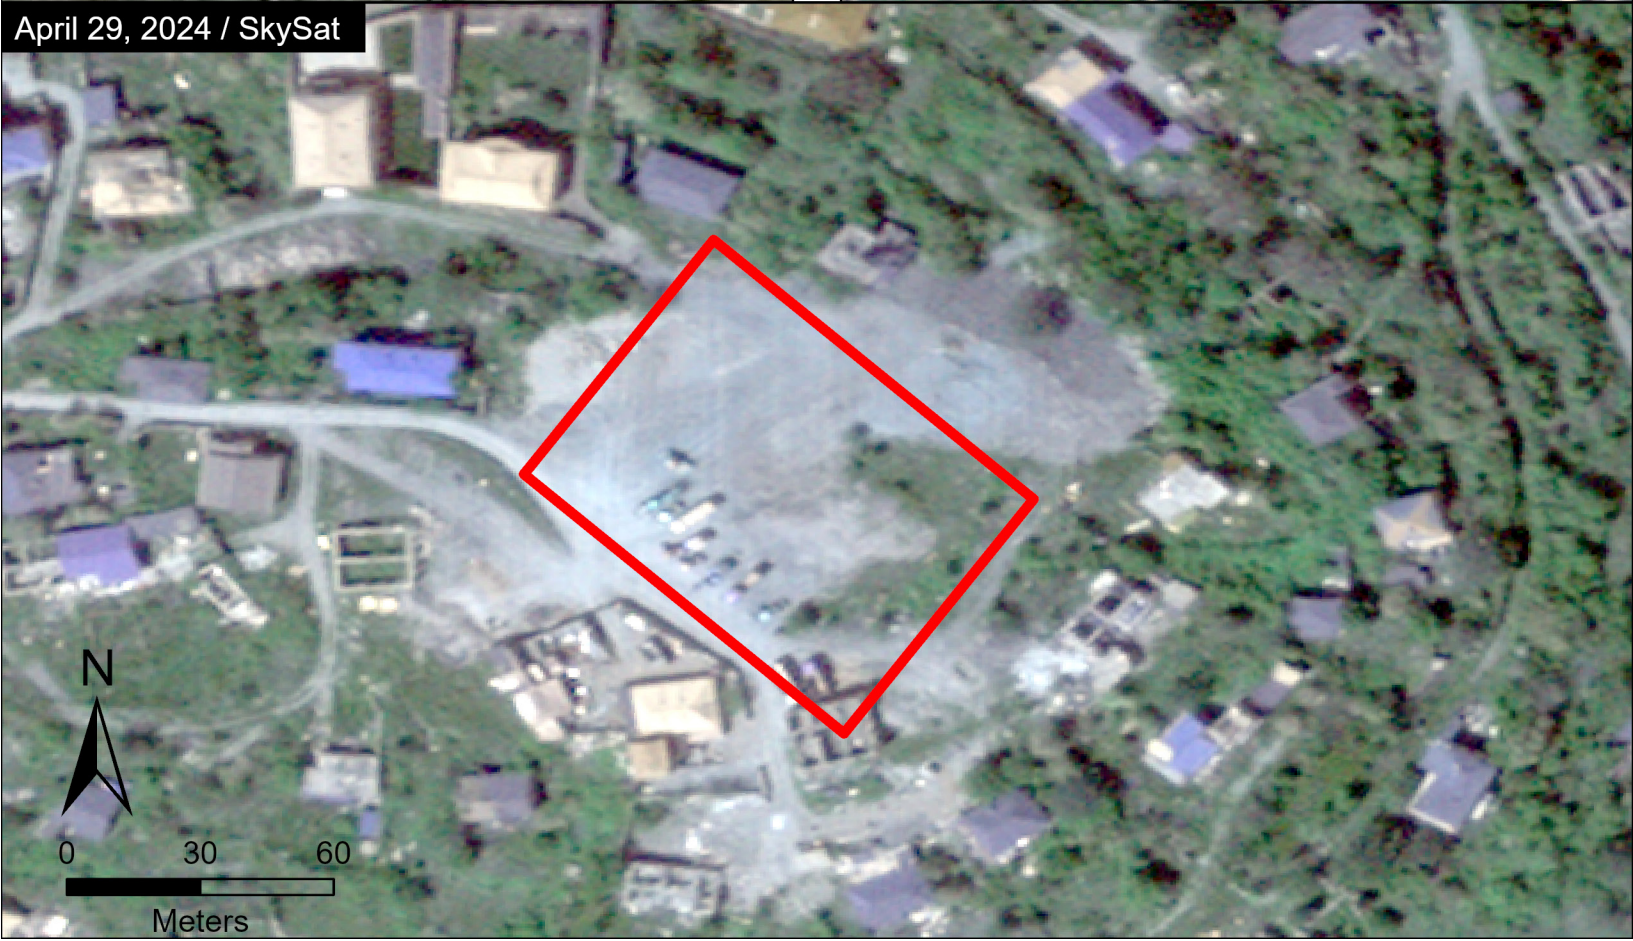
SH.103-0 Ghazanchetsots Cemetery of Shushi/Shusha

Destroyed Heritage	
SH.103-0	Ghazanchetsots Cemetery
Dates	18th-19th centuries
Baseline Image	2023-10-05 / SkySat
Monitoring Images	2023-11-03 / SkySat
Current Status	Destroyed
Notes	<p>In our last CHW Monitoring Report, we documented damage to the Ghazanchetsots Armenian cemetery in Shusha/Shushi as our satellite imagery showed piles of debris had been heaped atop the site.</p> <p>The 18th-19th c. cemetery had been severely damaged during the Soviet era. By the 1990s, 45 tombstones remained. One marks the passing of Stepan, a blacksmith from Ghazanchi village in Nakhchivan, who died in 1758. He was one of many Armenian migrants from that village whose name was given to the city's well-known cathedral. Stepan's tombstone recalls the destruction of the Armenian cemetery in his native village, the Old Cemetery of Ghazanchi/Shahkert. CHW documented its erasure in our investigation into the recent destruction of Armenian cultural heritage in Nakhchivan. In that investigation, we also documented the destruction of the medieval Armenian monastery in the blacksmith's native Ghazanchi.</p> <p>Between November 3, 2023 and April 29, 2024, the entire territory of the cemetery was razed and the surface graded. Vehicles can be seen in the most recent image at right parked atop the former cemetery.</p>
