CAUCASUS HERITAGE WATCH

MONITORING REPORT
JUNE 2024

Monitoring Report #7
June 2024

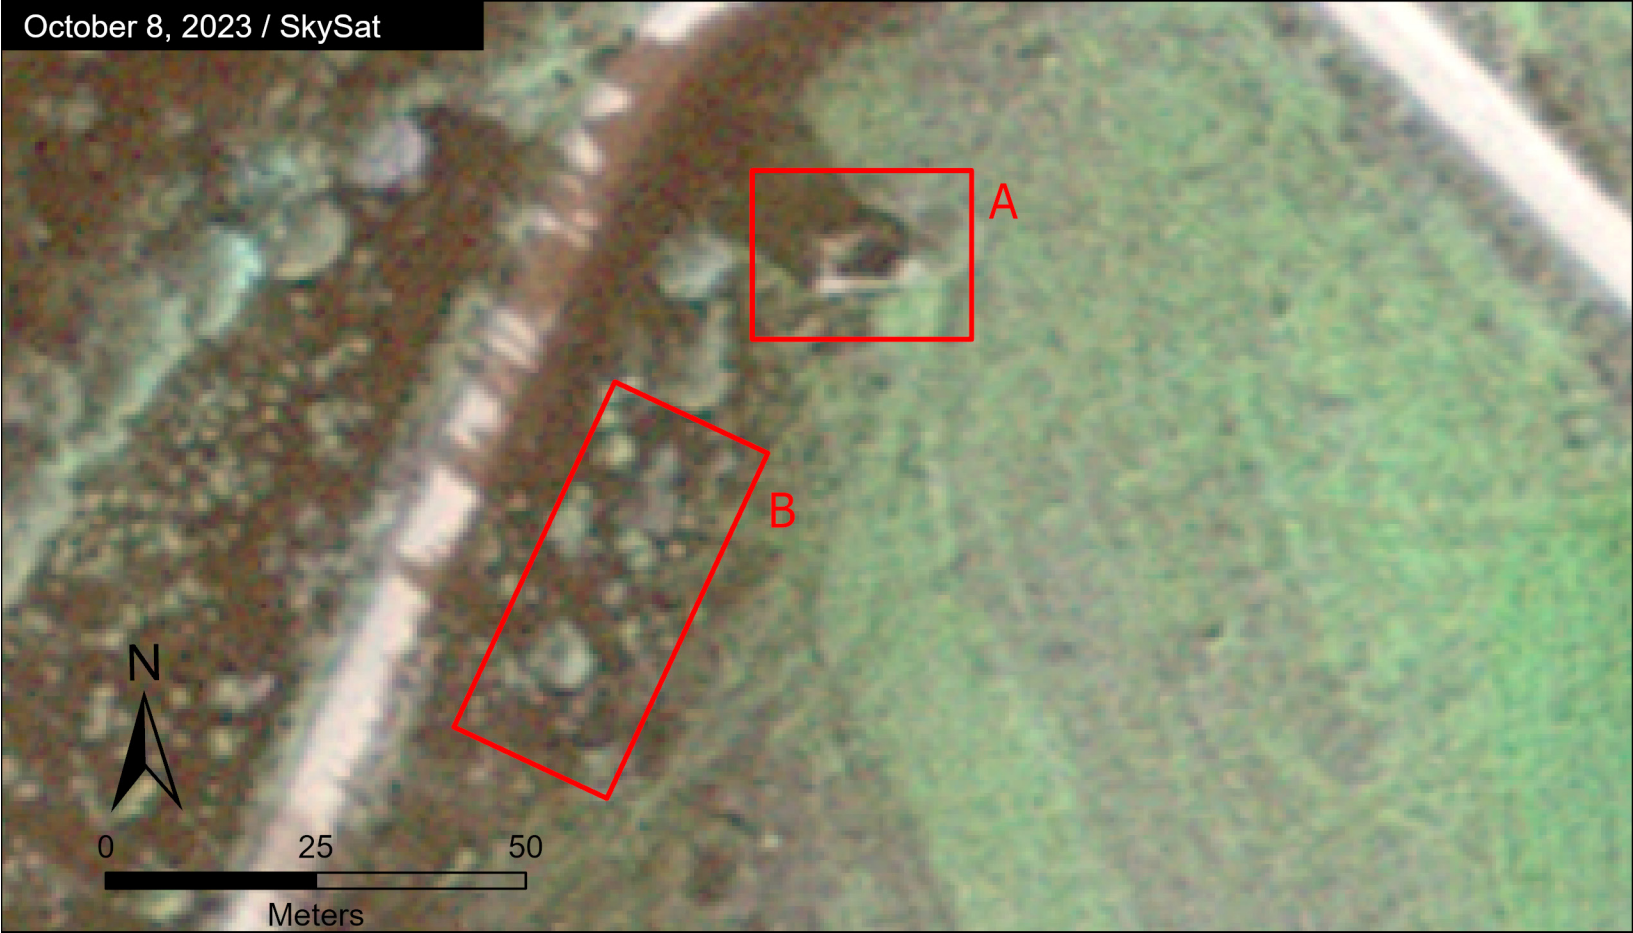
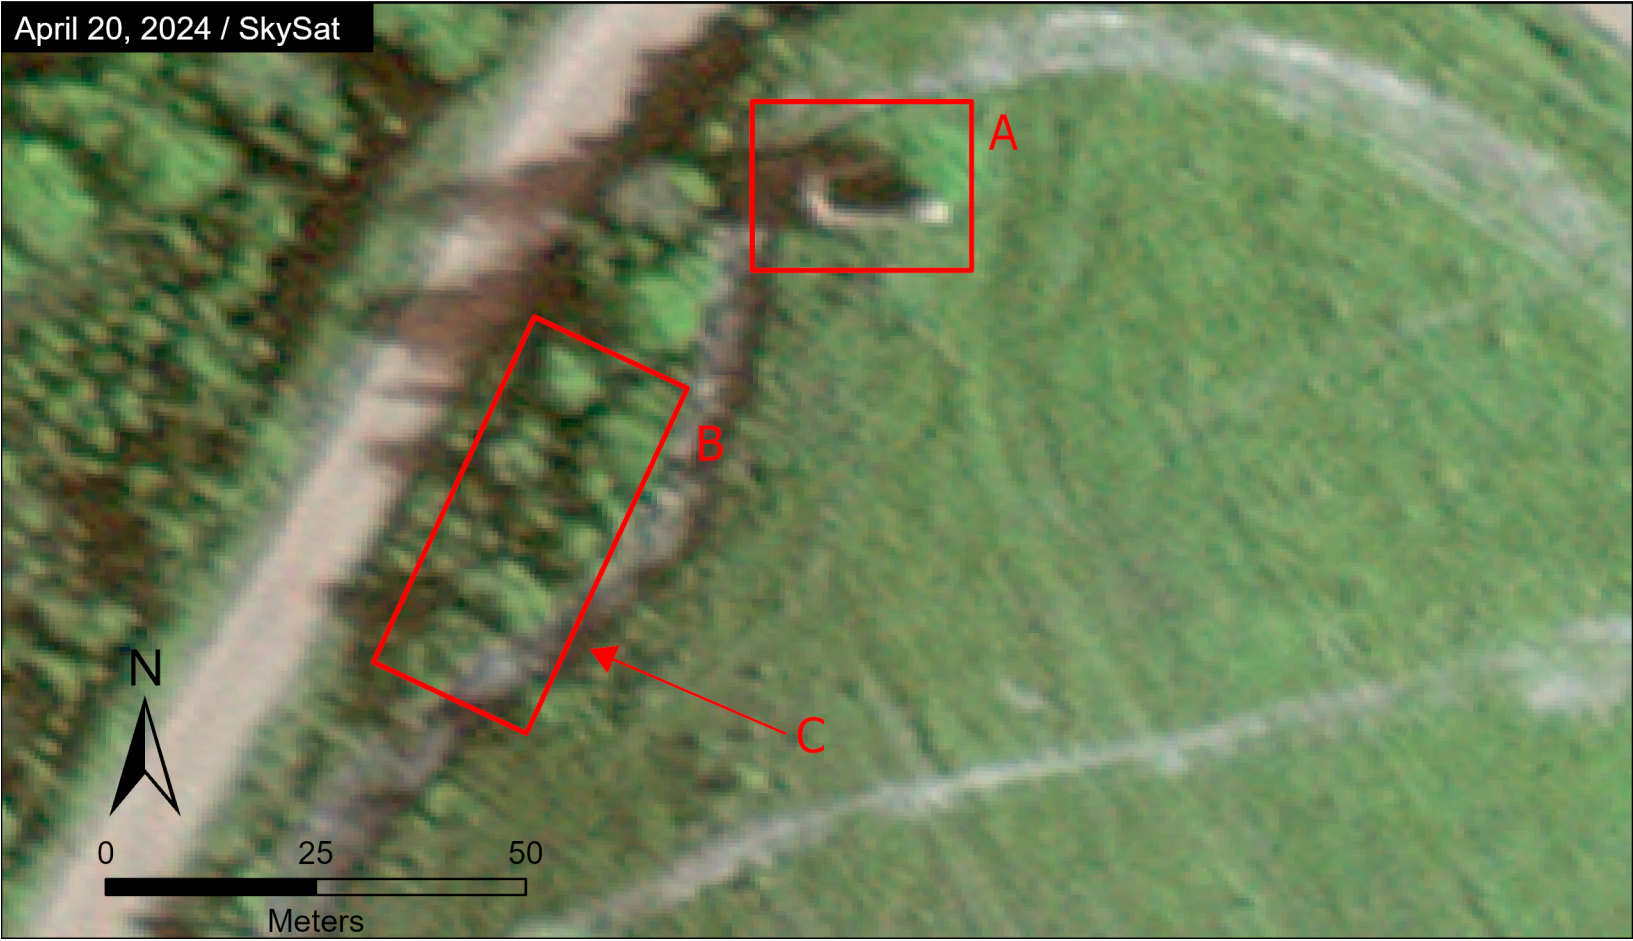
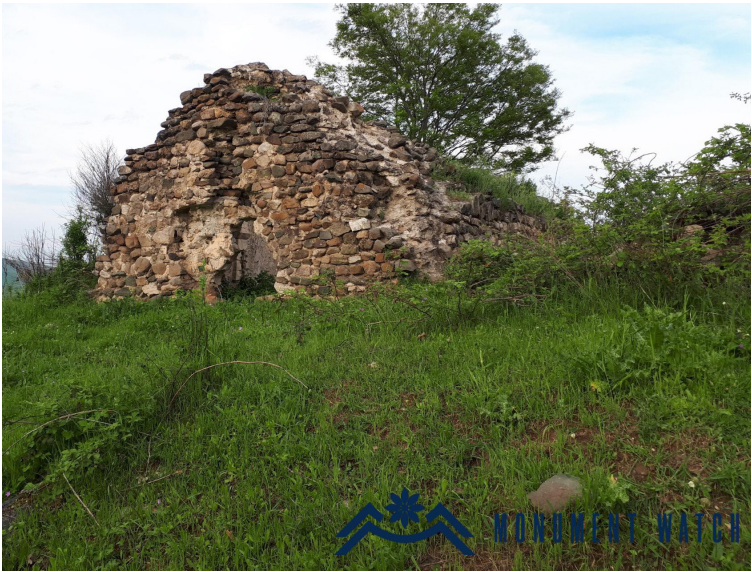
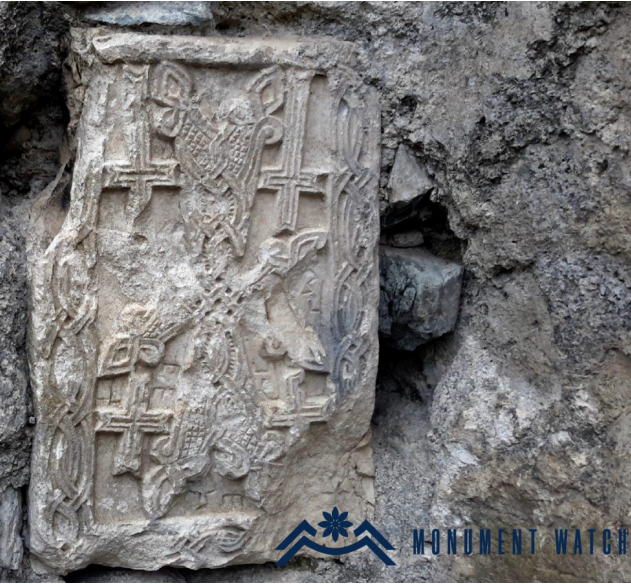
HT.039-0. Ptkat'aghi Vank' Church &
HT.039-1. Ptkat'aghi Vank' Cemetery

Threatened Heritage	
HT.039-0, HT.039-1	Ptkat'aghi Vank' Church & Cemetery
Location	Hunarli/Tsakuri
Dates	1670
Baseline Image	2023-10-08 / SkySat
Monitoring Images	2024-04-20 / SkySat
Current Status	Threatened
Notes	<p>All that remains of this 17th century monastery are the ruins of its church (A), a single-naved hall with semicircular apse on the eastern side. More information about the church can be found on the Monument Watch website, here. A cemetery (B) sits in the forested area to the southwest of the church.</p> <p>Between October 8, 2023 (at right, top) and April 20, 2024 (at right, bottom) a 7-8m wide path was cut that skirted around the northwest corner of the church and intruded into the southeast corner of the cemetery (C).</p>
Alerts	None
Image Credit	Monument Watch

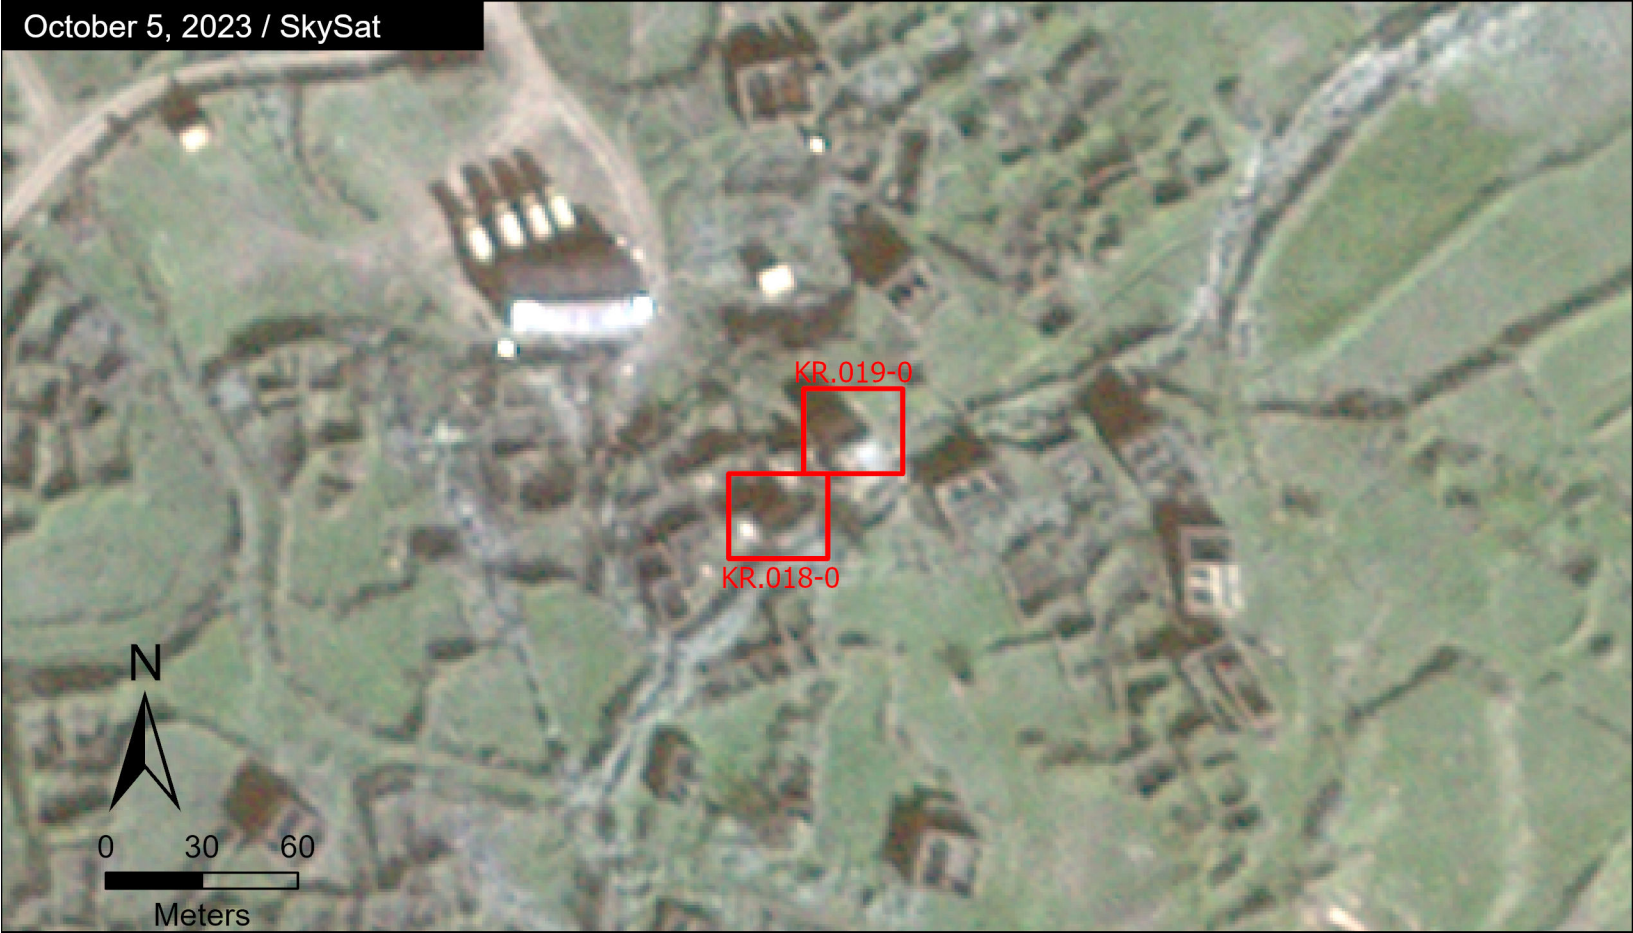
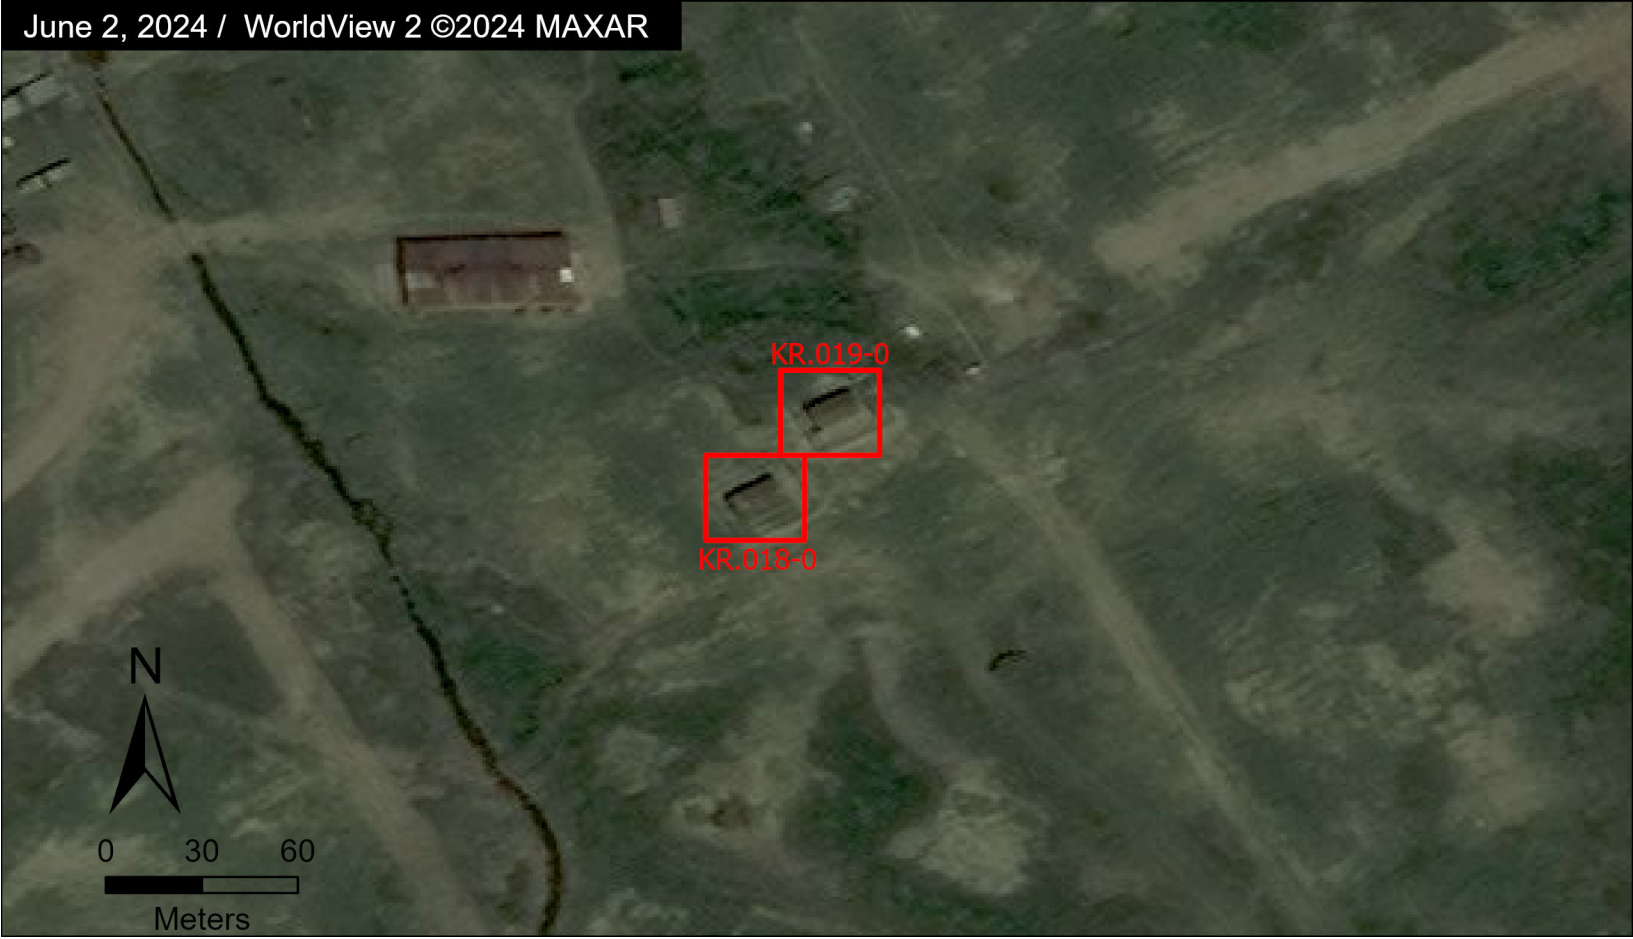
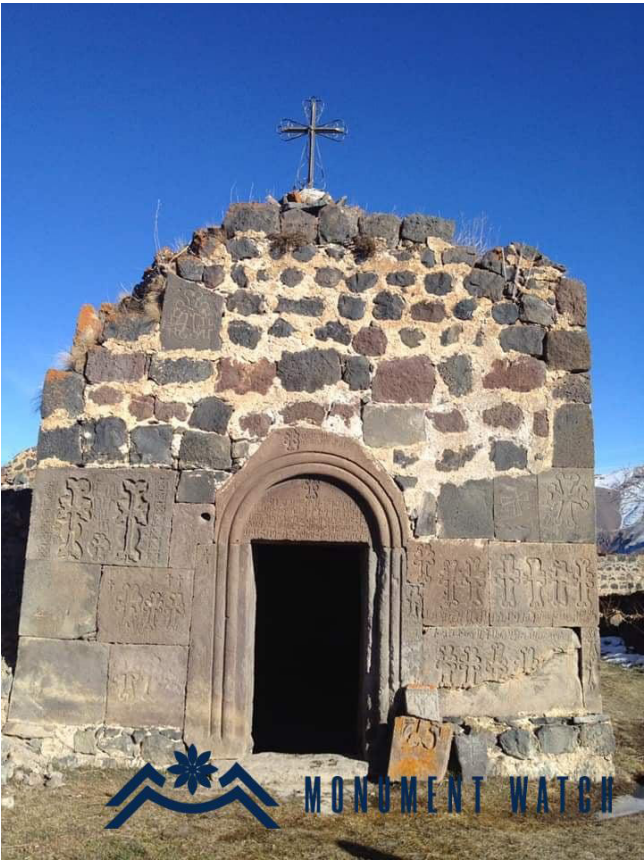
KR.018-0. Surb Sargis Church &
KR.019-0 Surb Grigor Church of Tsar / Zar

Threatened Heritage	
KR.018-0, KR.019-0	St. Sargis and St. Grigor Churches
Location	Zar/Tsar
Dates	St. Grigor: 1274; St. Sargis: 1279
Baseline Image	2023-10-05 / SkySat
Monitoring Images	2024-06-02 / WorldView 2 ©2024 MAXAR
Current Status	Threatened
Notes	<p>The chuches of St. Sargis and St. Grigor, in Zar, are both single nave chapels built in the 13th century. More information can be found on the Monument Watch website, here. St. Sargis is particularly threatened due to the 8 Armenian inscriptions on the walls of the church.</p> <p>Between October 5, 2023 and June 2, 2024, the standing ruins of Zar were removed and the terrain graded. Only the two Armenian church-es remain standing.</p>
Alerts	Mentioned here , in CHW's story Map about the destroyed schools of Zar and Chirag, which we released as an alert on social media on June 13. 2024.
Image Credit	Photo of the western facade of St. Sargis, courtesy of Monument Watch

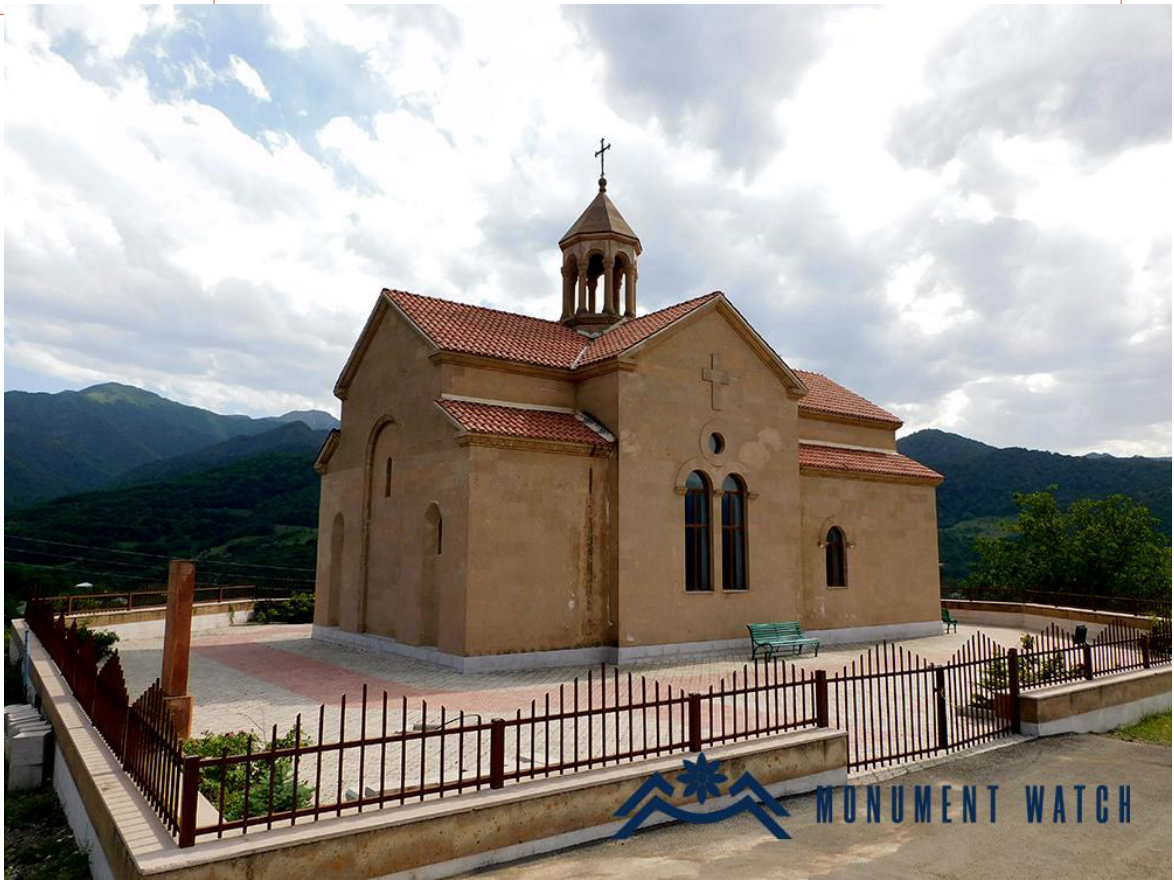
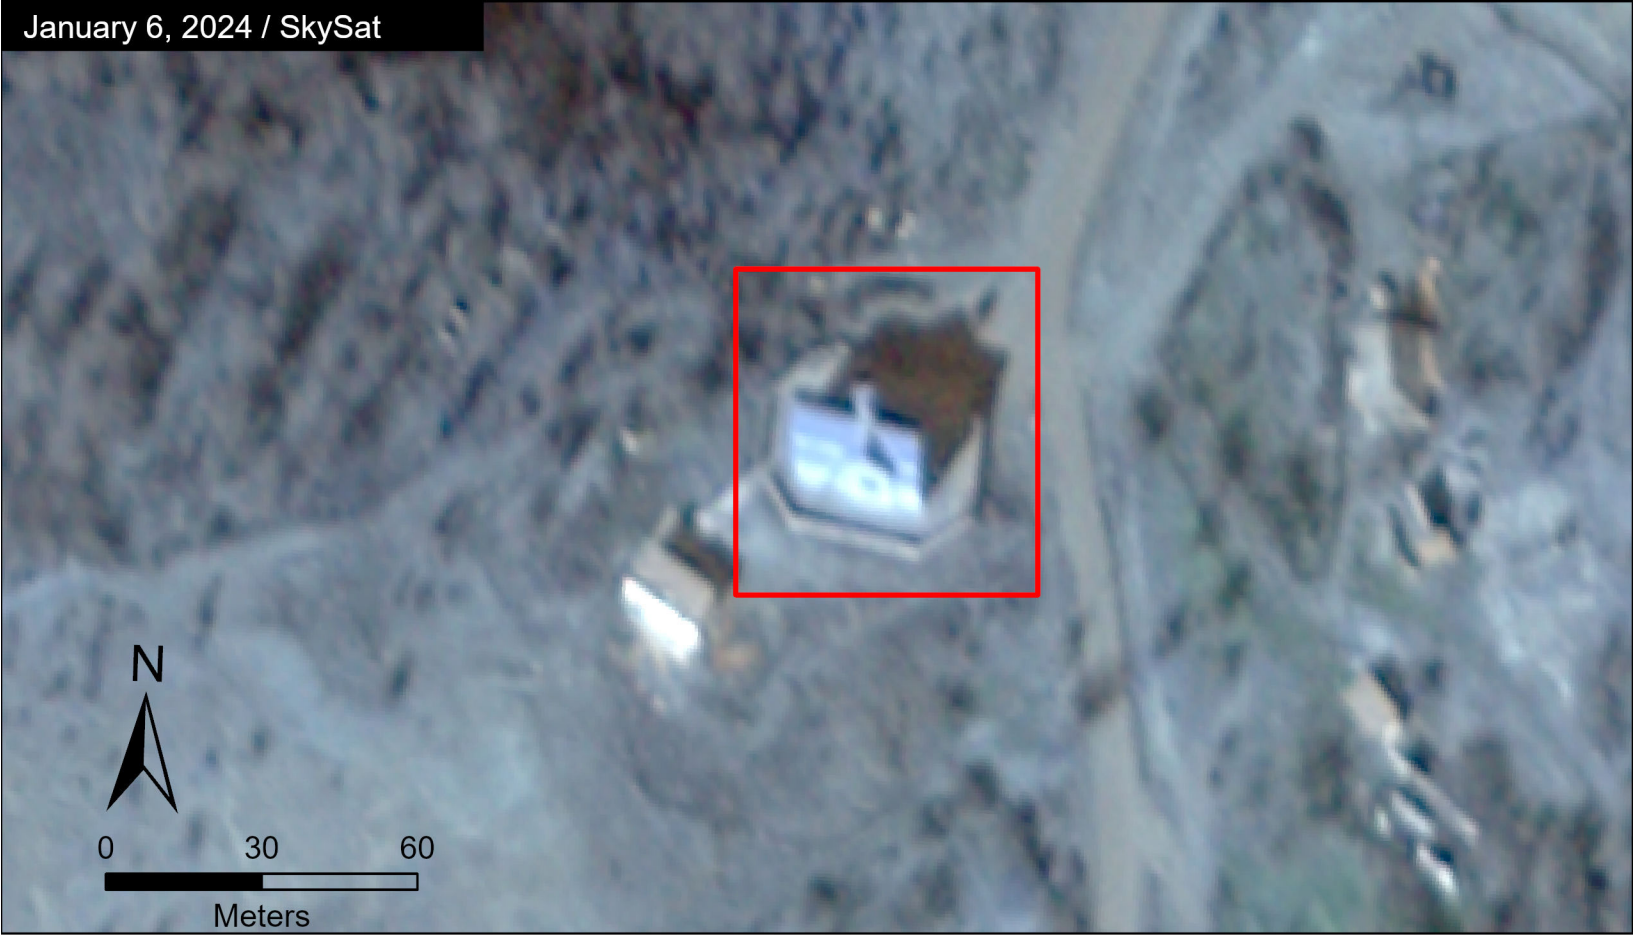
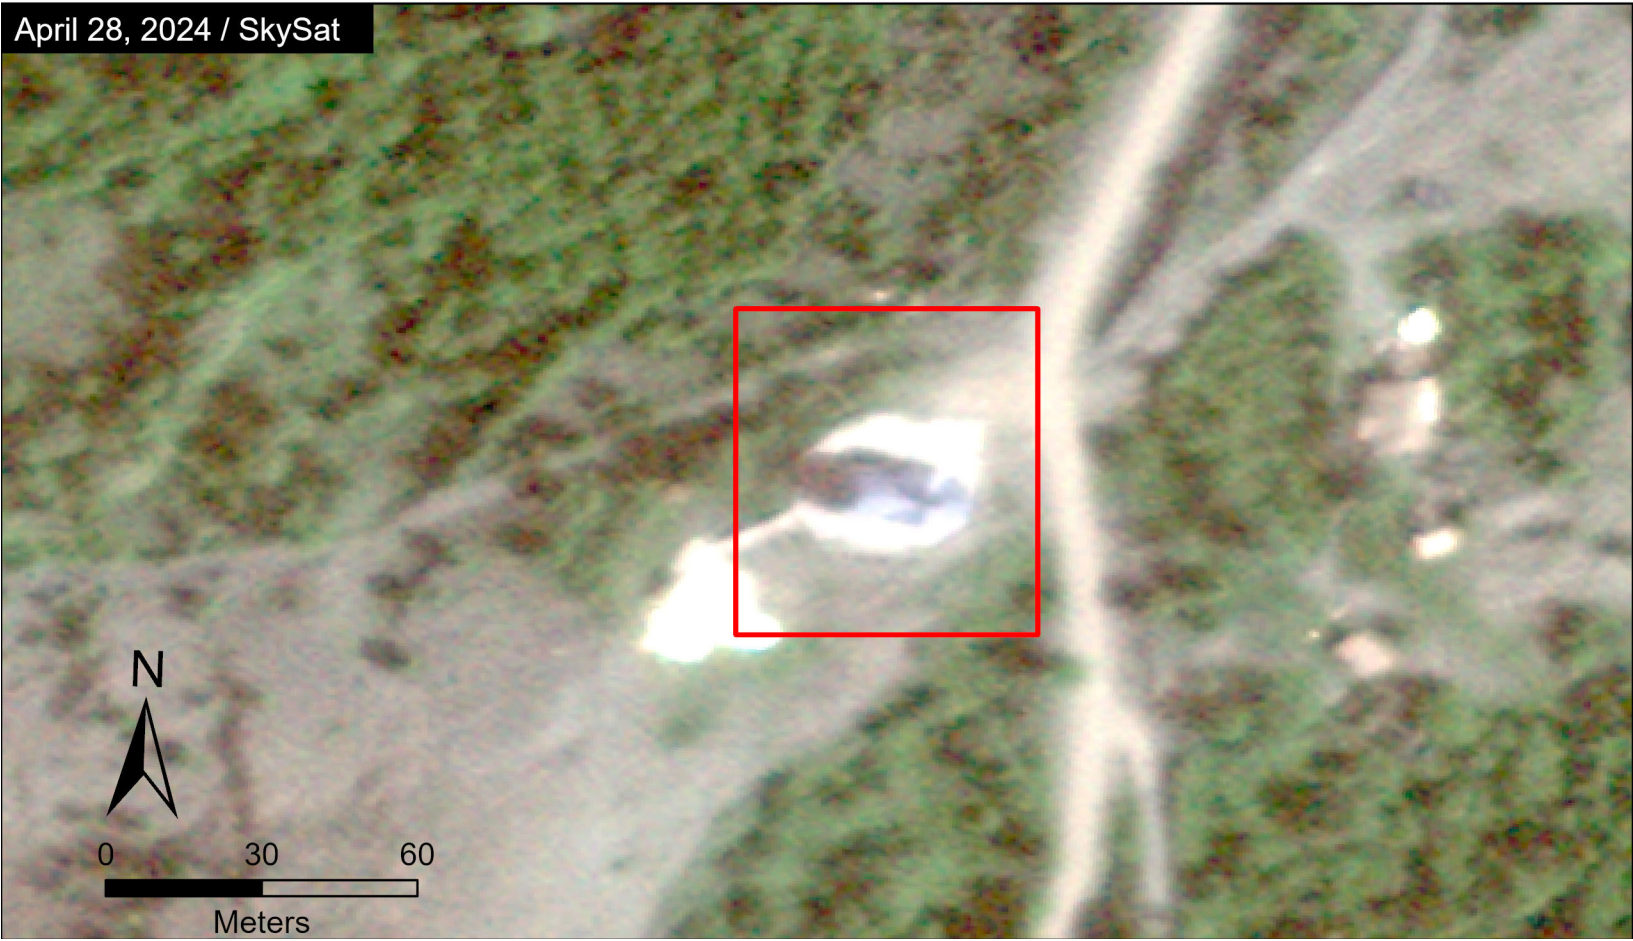
MT.456-0. Surb Mariam Astvatsatsin of Gozlu/Vaghuhas

MT.456-0	Surb Mariam Astvatsatsin of Vaghuhas/Gozlu
Location	Goslu/Vaghuhas
Date	2012
Baseline Image	2024-01-06 / SkySat
Monitoring Images	2024-04-28 / SkySat
Current Status	Threatened
Notes	<p>This white limestone church was begun in 2007 and consecrated in 2012. Additional information can be found on the Monument Watch website, here.</p> <p>Between January 4 and April 28, 2024, earthmoving activity around the church destroyed the patio and a structure just to the southwest, where candles and souvenirs were sold.</p>
Alerts	None
Image Credit	Monument Watch

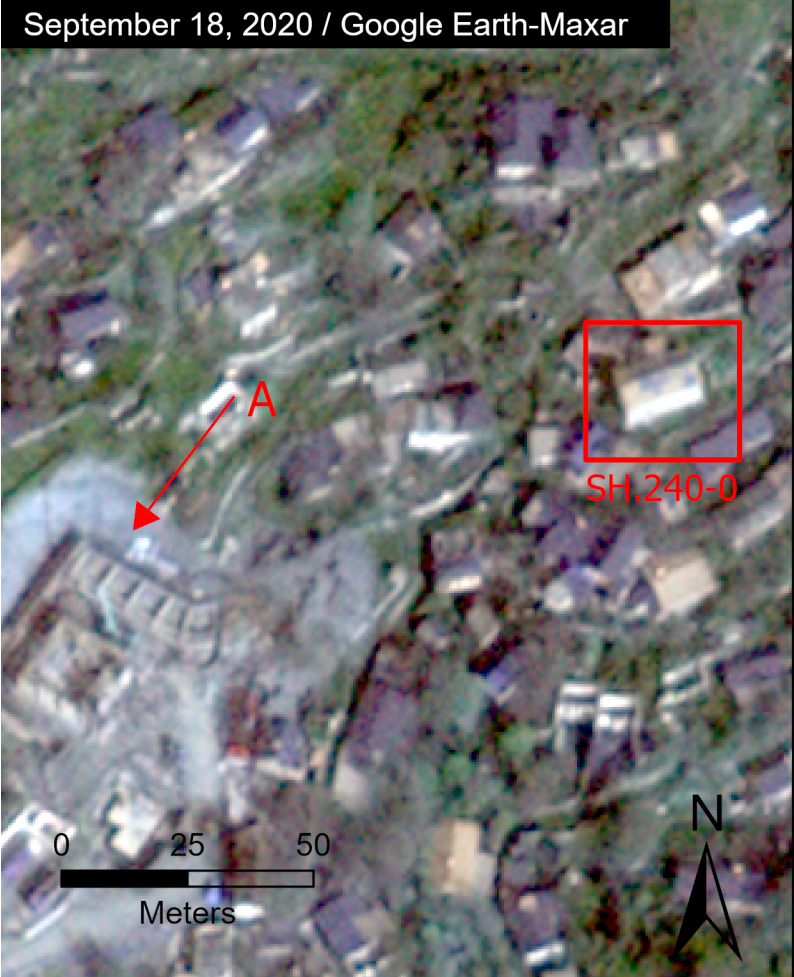
SH.240-0 Surb Astvatsatsin of K'arin Tak/Dashalty & SH.257-0 Dashalty/K'arin Tak Cemetery

Threatened Heritage	
SH.240-0, SH.257-0	Surb Astvatsatsin church & village cemetery
Location	Dashalty/Karin Tak
Dates	Surb Astvatsatsin: 1841 Cemetery: modern (founding unknown)
Baseline Image	2020-09-18 / SkySat
Monitoring Images	2023-12-20 / SkySat & 2024-04-04 / Google Earth-Airbus
Current Status	Threatened
Notes	<p>The Surb Astvatsatsin church of Karin Tak sits on the eastern side of the historic Armenian village. According to inscriptions on the church facades, it was built in 1841 and renovated in 1903. The single nave basilica was renovated again in 2000. Additional information can be found on the Monument Watch website, here.</p> <p>A September 18, 2020 image shows the initial stage in the construction of a new mosque (A) amidst the standing houses of the village (at right, top left). A December 20, 2023 image (at right, top right) shows work on the mosque continuing even as the homes of the entire village have been razed. Only a single structure remains standing amidst the ruins: Surb Astvatsatsin church. By April 4, 2024 (at right, bottom) the bulldozers had demolished the village, approaching the edge of the cemetery (B). The church remains standing amidst the debris.</p>
